Periodic Inspection of St. Paul Harbor Breakwater, Alaska

Robert R. Bottin, Jr., and Alan C. Jeffries

February 2001

Final report

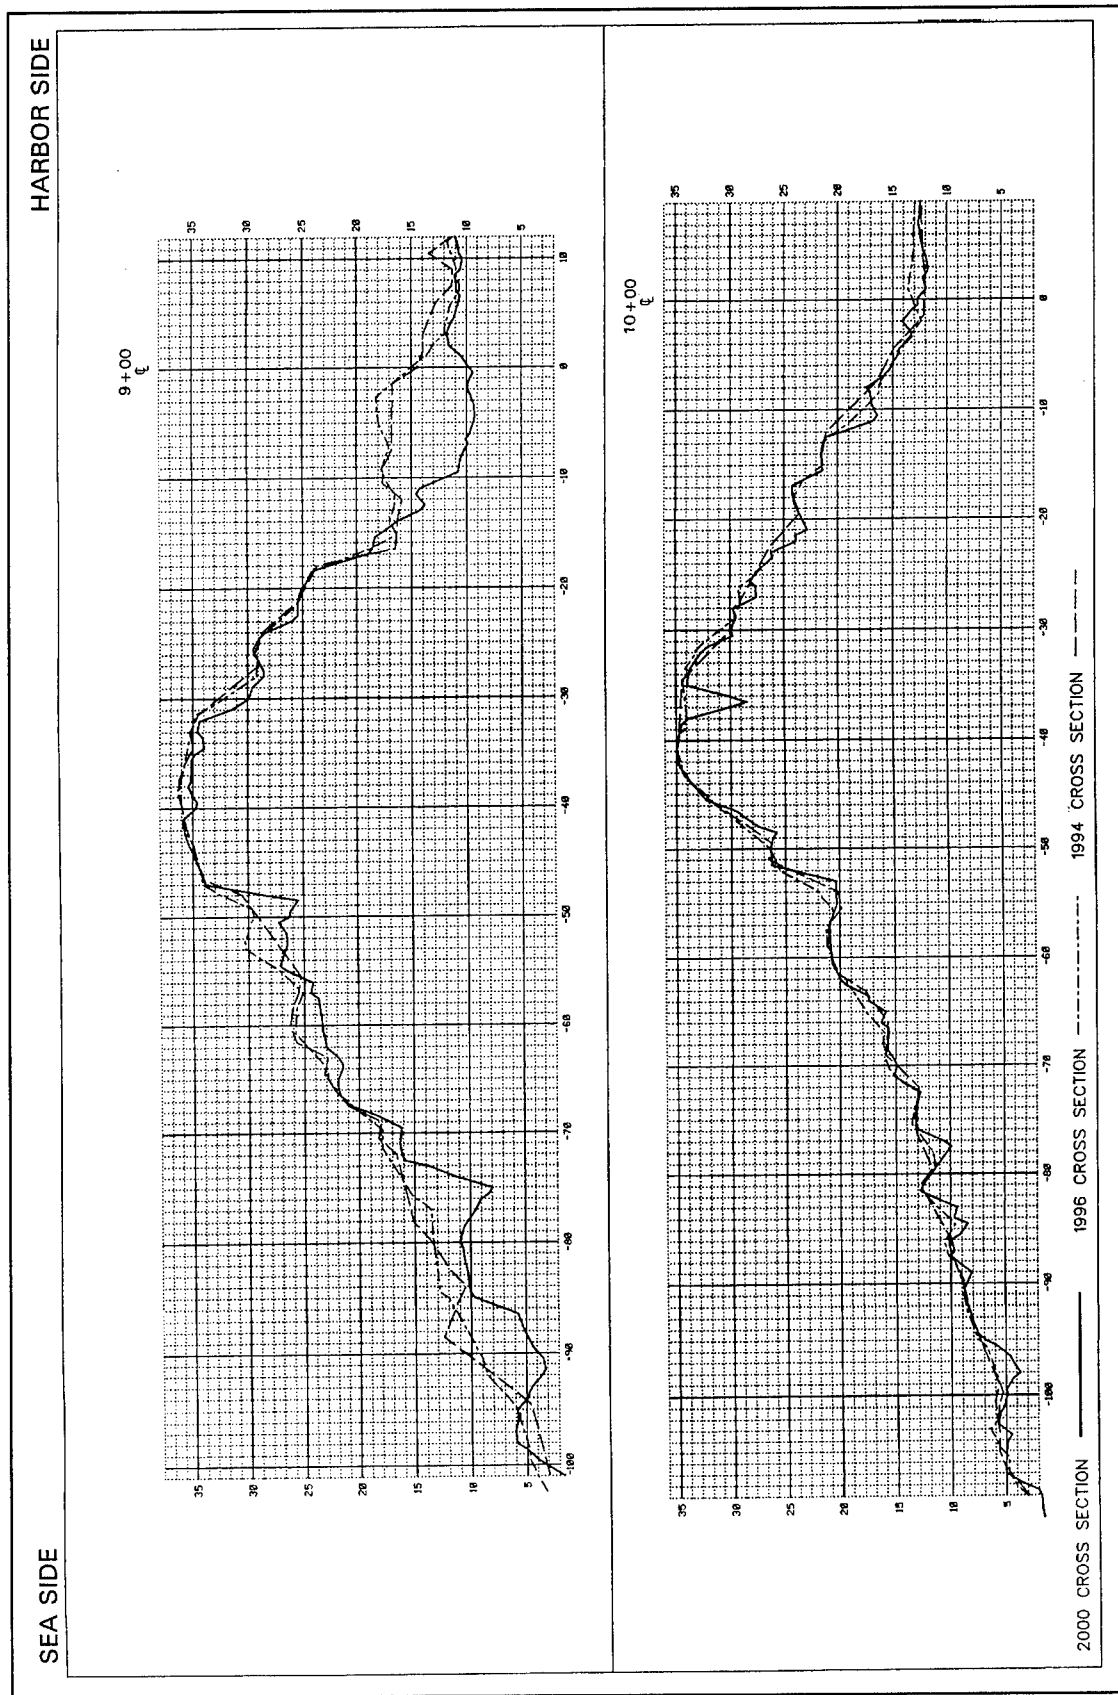
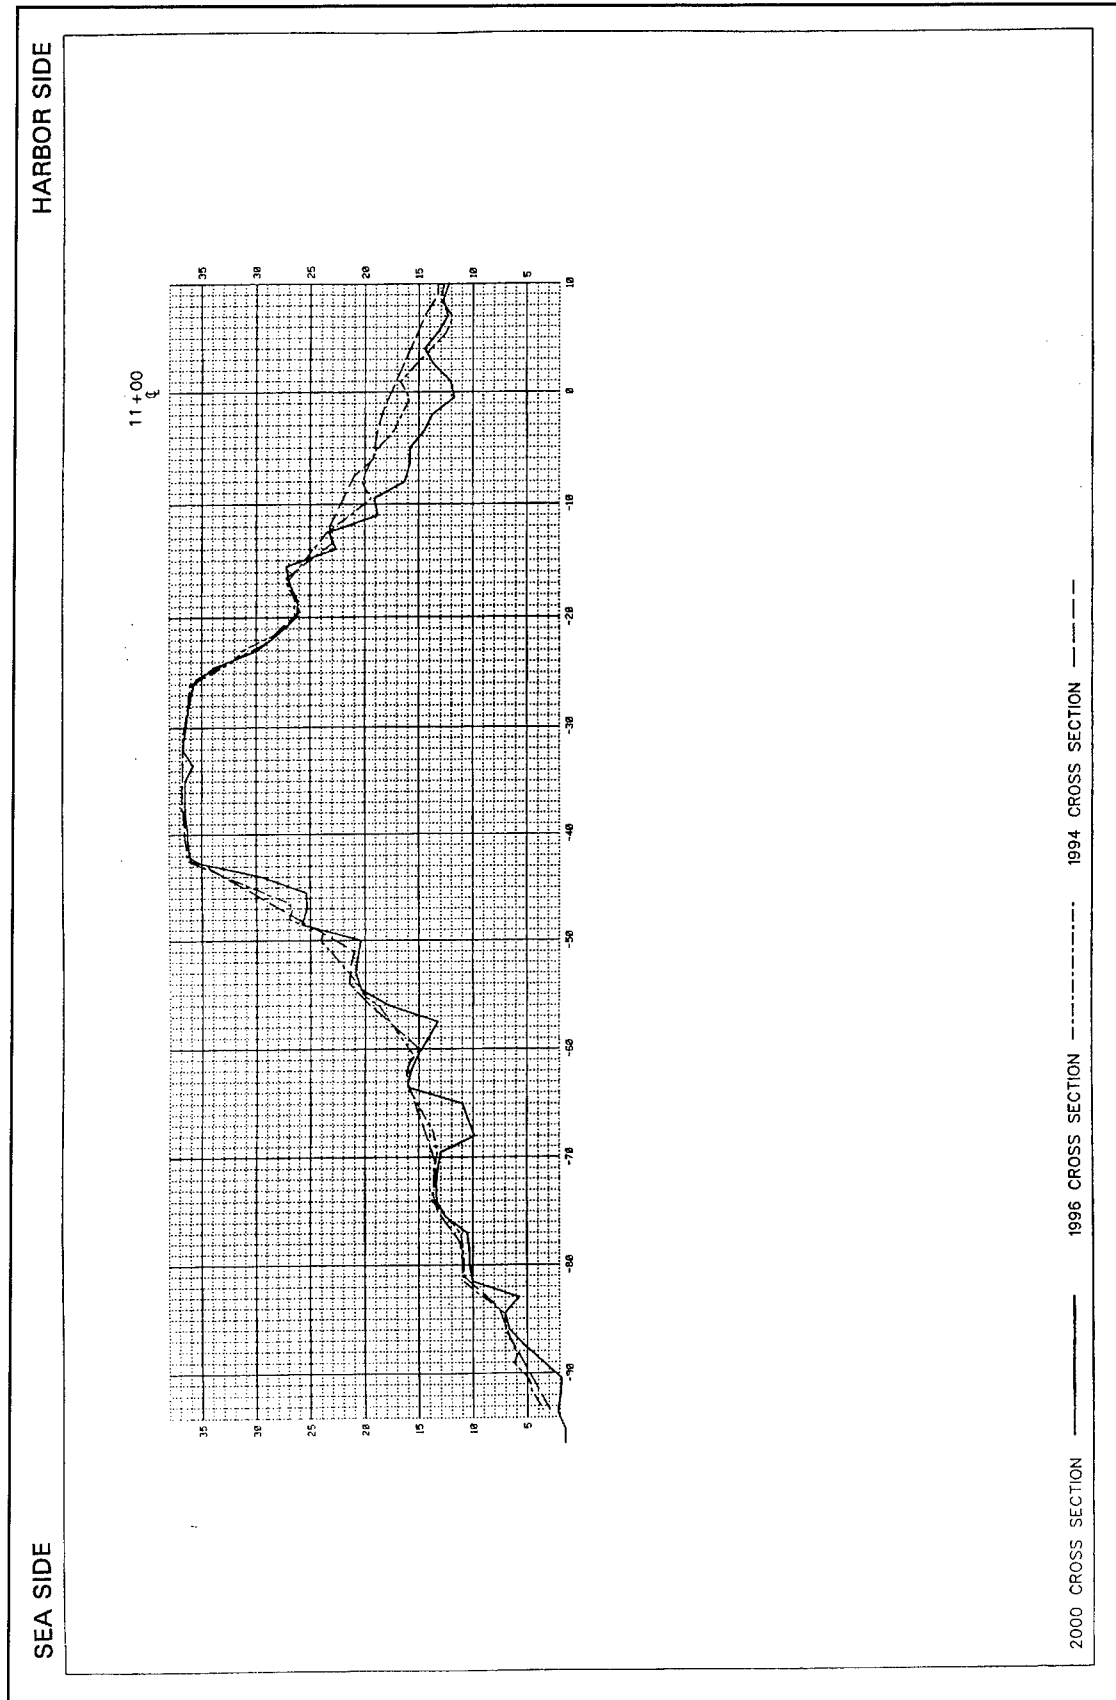
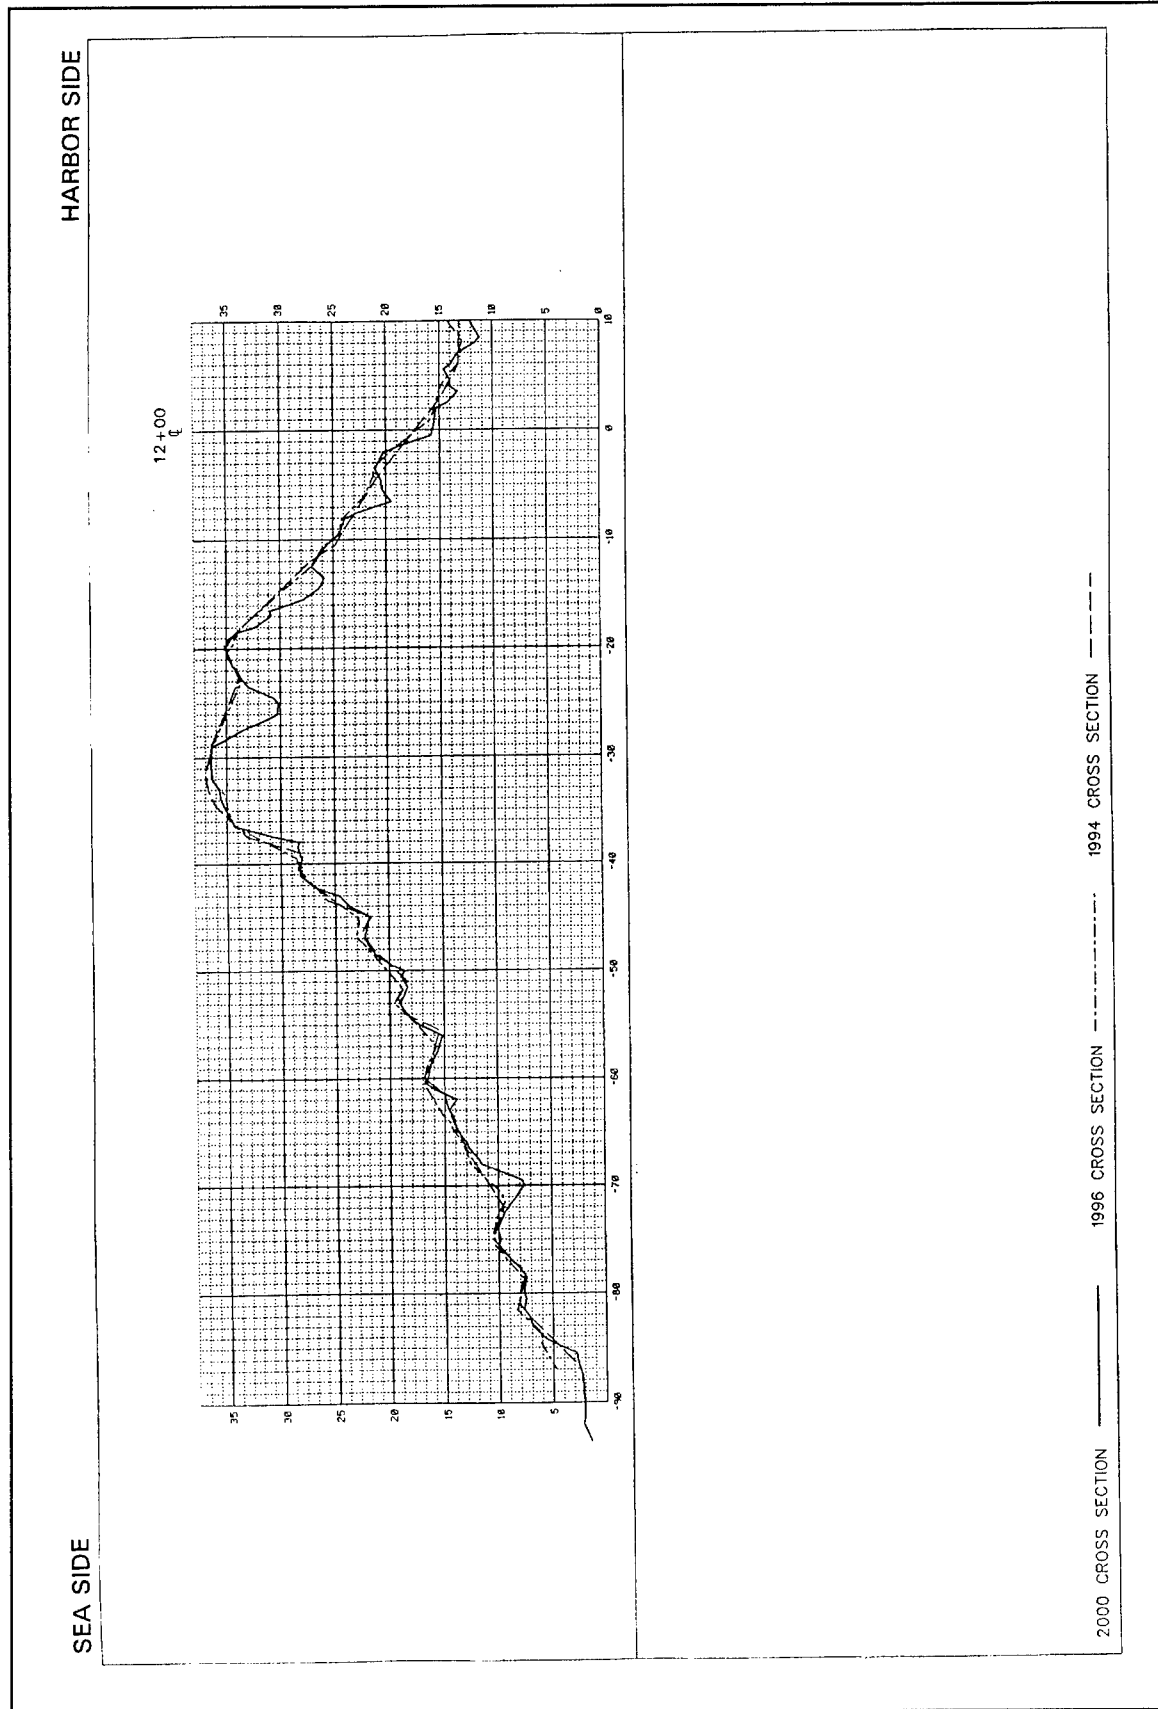
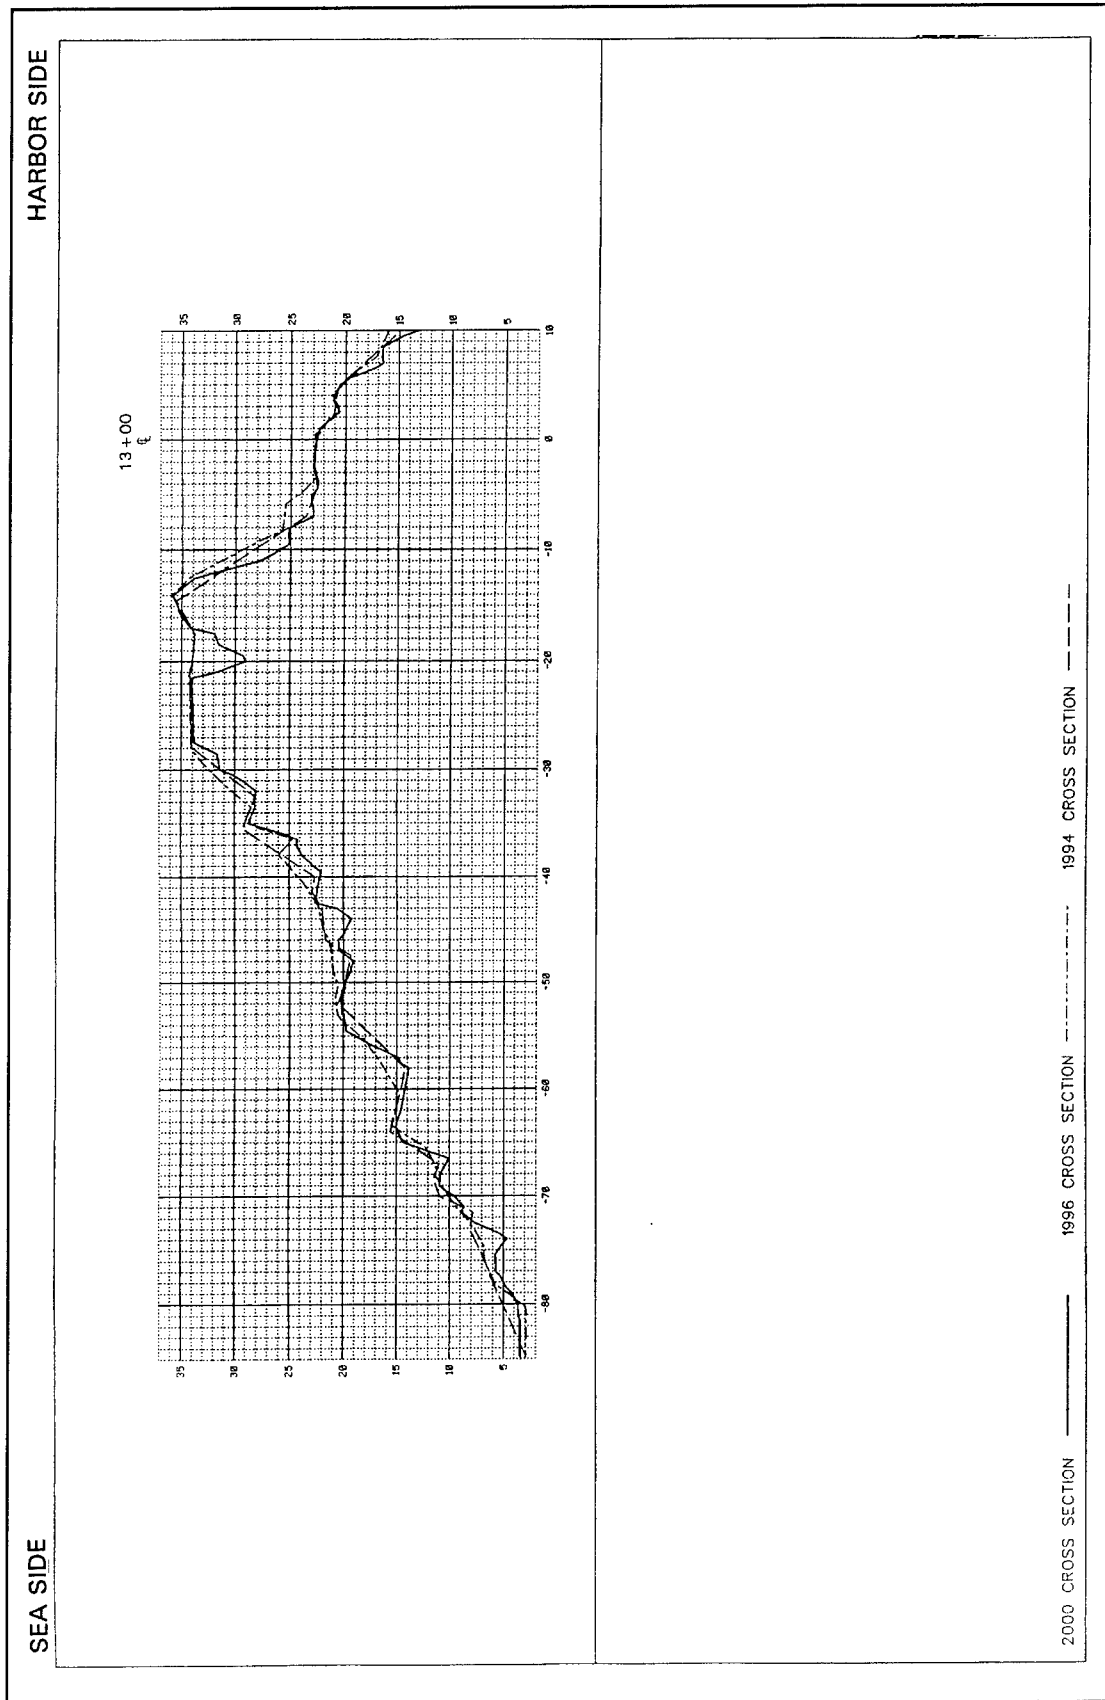
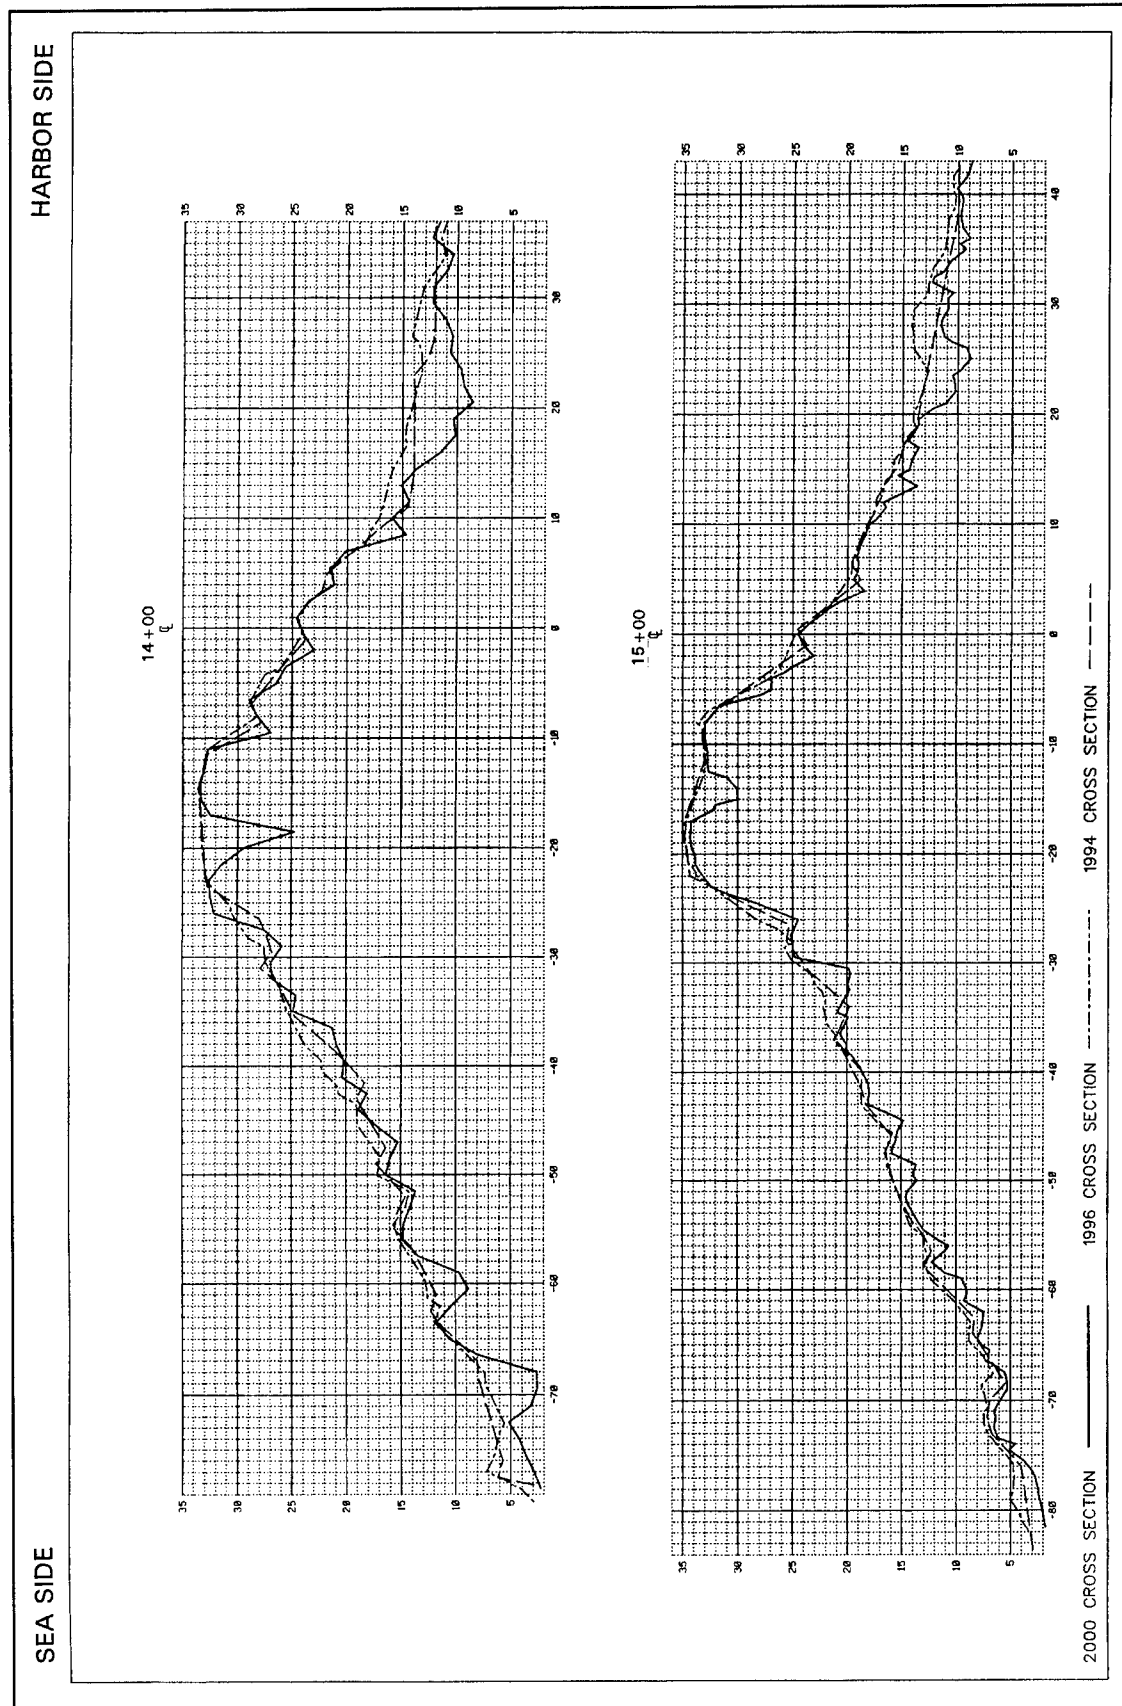
Examination of cross section data revealed that cross sections of the breakwater were similar in both 1994 and 1996. Accretion of stone along the toe of the harbor side slope of the structure was apparent at stas 11+00, 12+00, and 13+00. This was an accumulation of small stones which was noted during a site visit in 1996. It is not known if this was core stone moving out of the breakwater due to wave action or loose stone moving over and/or through the voids of the structure during storms.

Examination of breakwater cross sections (Appendix B) reveals low areas in the breakwater based on data obtained in 2000 versus that of 1994 and 1996. The overall shape and elevation of the structure appear to be generally the same, but voids were noted in most cross sections of the current (2000) survey that were not present in the previous ones. Some of these voids were located on the crest of the structure and others along the slopes. The breakwater appears to have lost stones in these low areas.
